Public Informational Meeting  
Improvements to Bashan Lake Dam  
DEEP Dam No. 4113  
East Haddam, Connecticut

June 27, 2013  
WMC Consulting Engineers, Newington, CT  
East Haddam Grange Hall

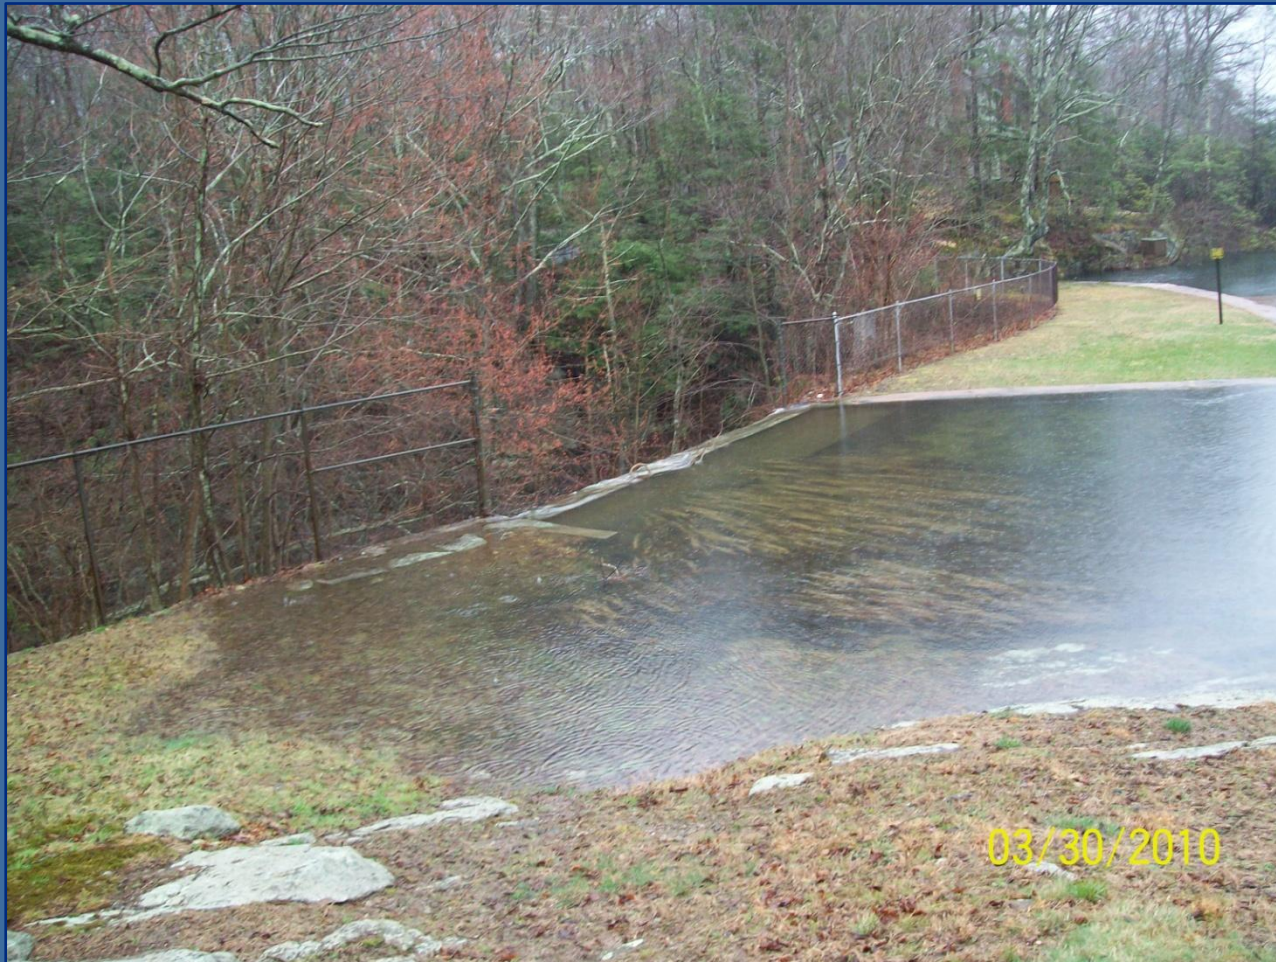
# Dam Overtopping (March 2010)

- Around 1966 dam ownership transferred from Moodus Reservoir Company to State of Connecticut
- June 1982 flood overtopped dam, causing some damage
- 1983 State repaired dam. Lake levels down  $\pm 16$  feet during repairs.
- March 2010 flood overtopped dam, no damages

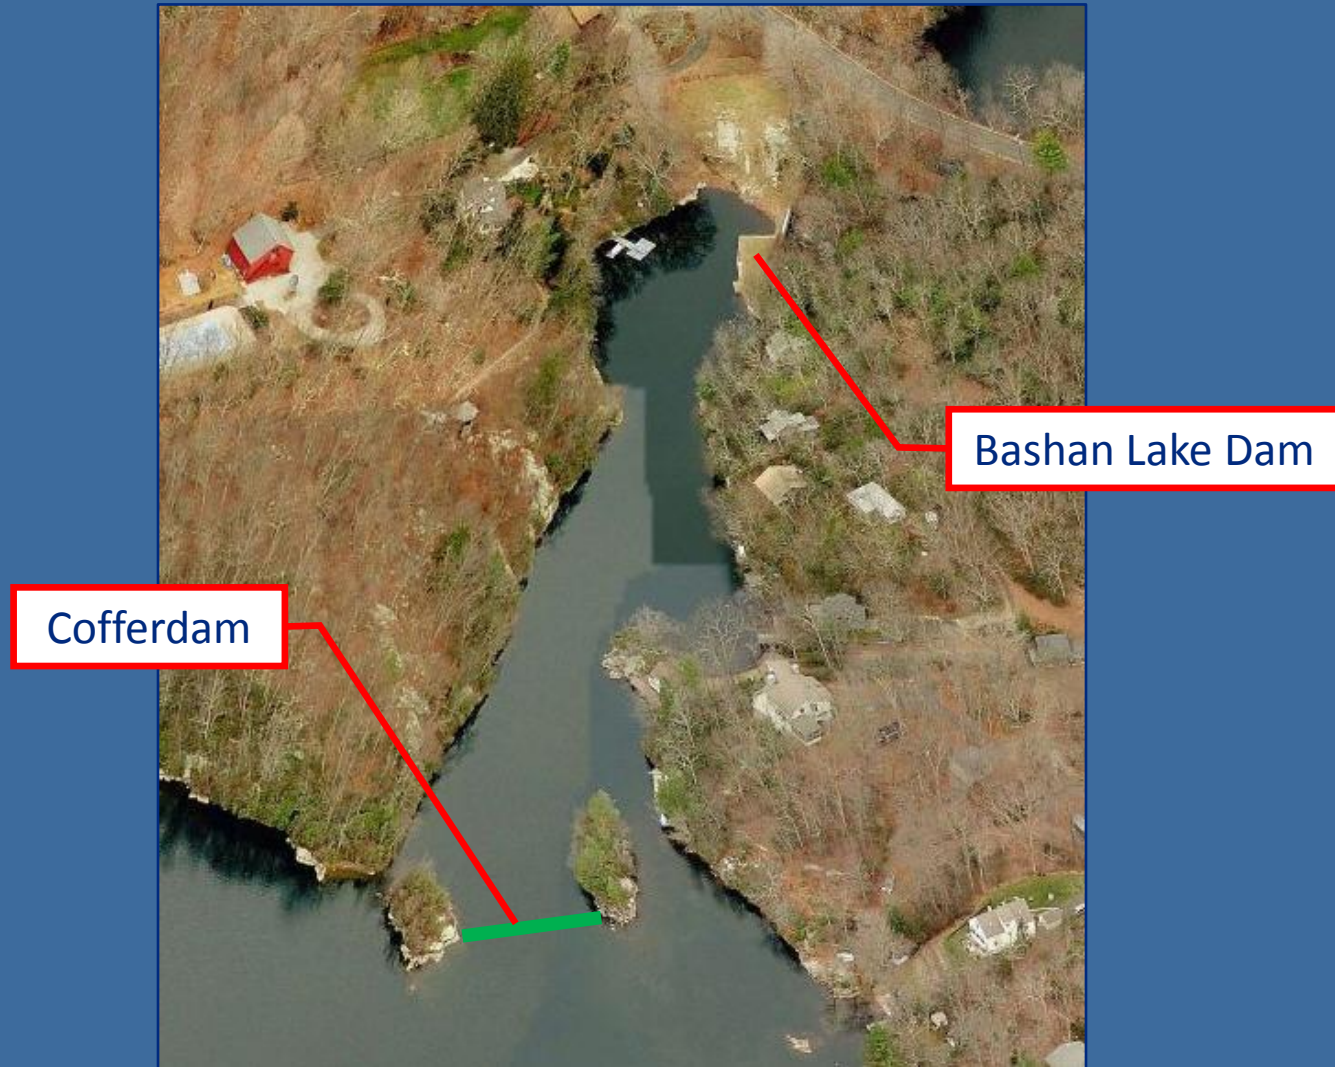
# Option B Cofferddam Location

120 foot long, 10 foot high cofferdam between two islands  
located at mouth of northerly cove

- Recreation-  $\pm 1$  foot down first summer
- Aquatic Vegetation- Potentially more growth
- Fisheries- Reduced impacts to Bridle Shiner
- Abutters- Primarily limited to first spring
- Cost-  $\pm \$150,000$  (second most expensive option)
- Lake Refilling-  $\pm 10$  months

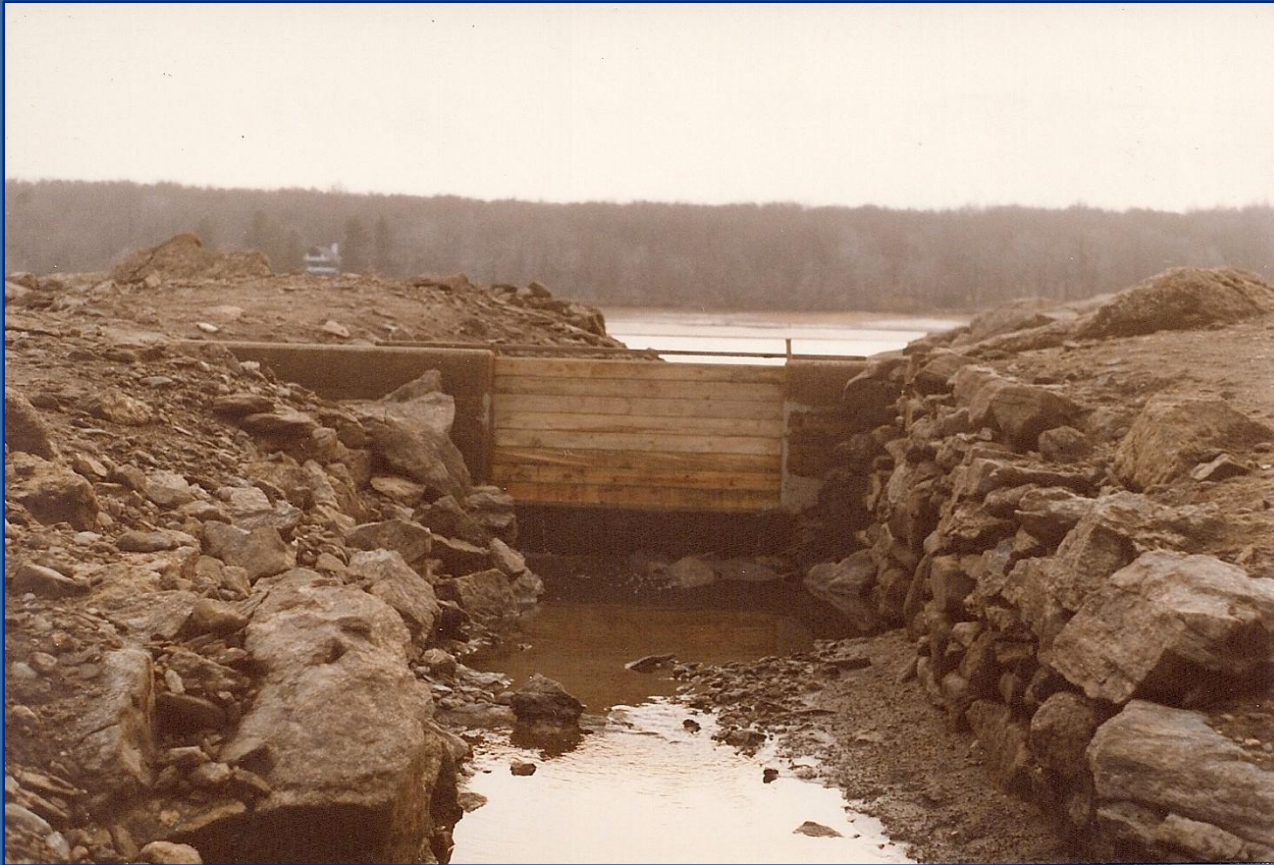
# Existing Cofferdam (1983 Repairs)

Install stop logs in existing cofferdam located between two islands at mouth of northerly cove

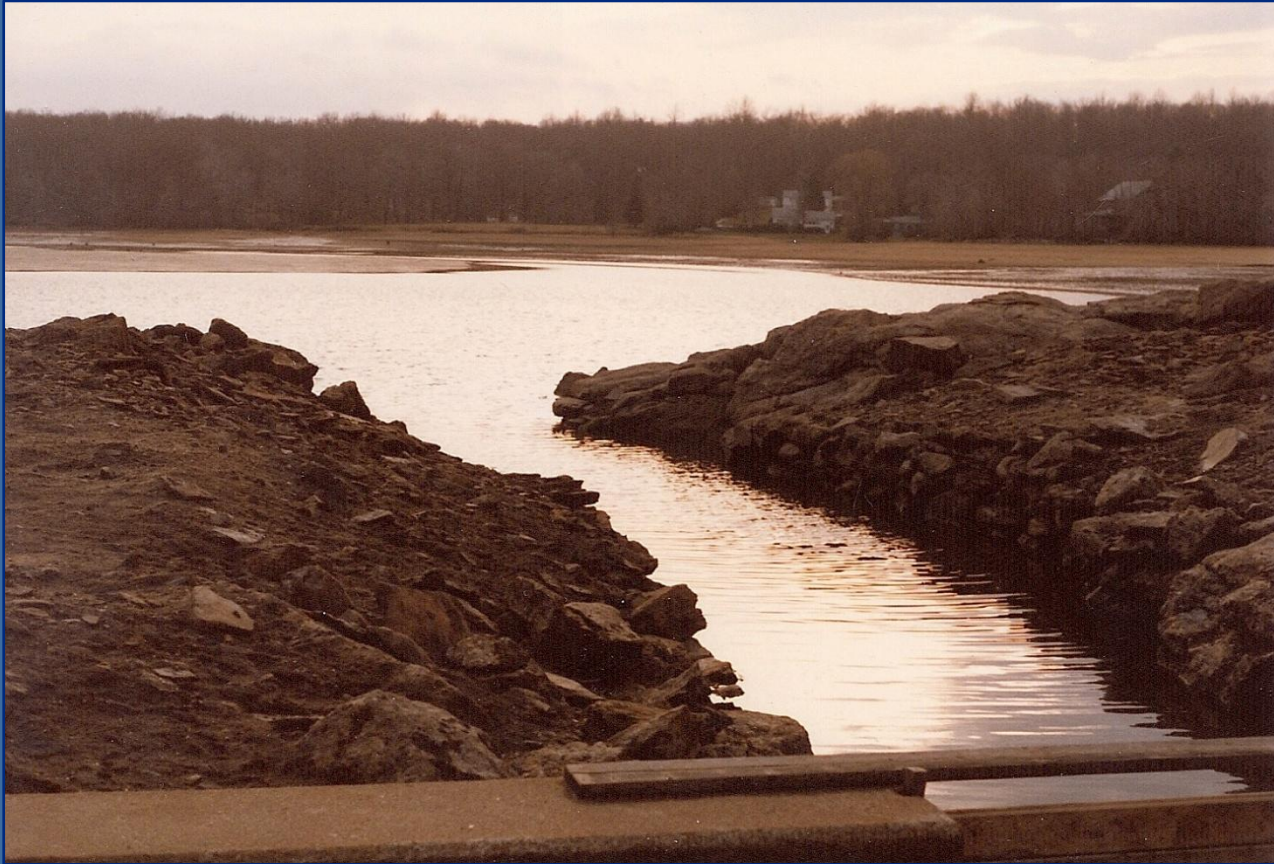
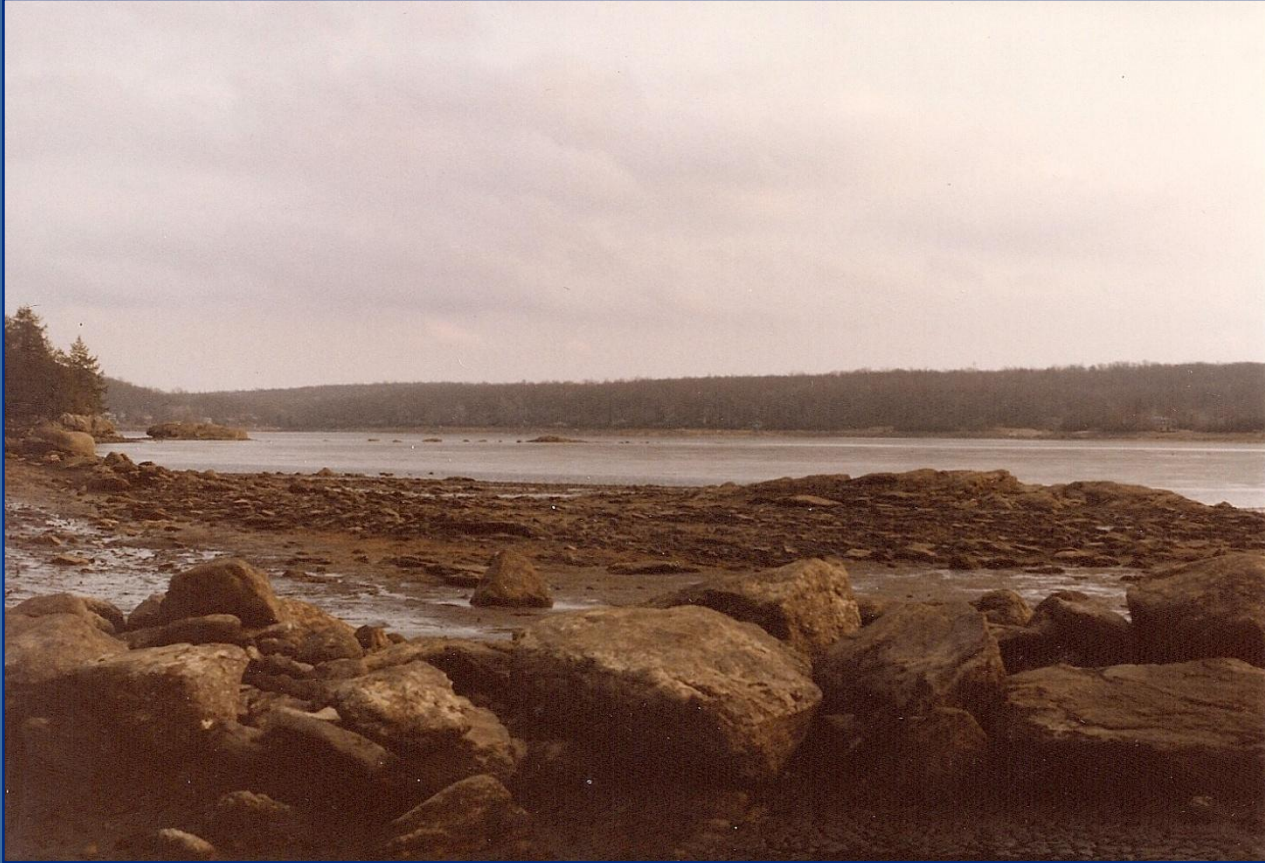
# ±16 Foot Drawdown (1983)

Utilize existing cofferdam located between two islands,  
without stop logs
